Photo.11 – Photographs of specimen before & after Impact test (Undischarged cells)

Photo.12 – Photographs of specimen before & after Impact test (Fully discharged cells)

Photo.13 – Photographs of specimen before & after Forced discharge test (Fully discharged cells)

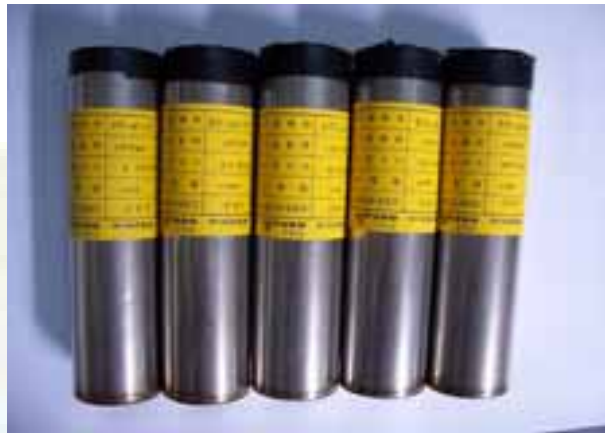
#11 ~ #15

Photographs of specimen before test

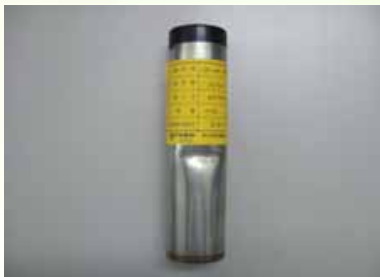
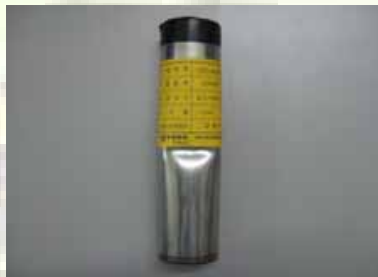
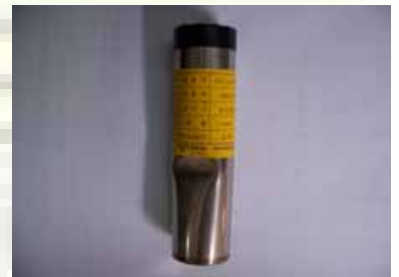
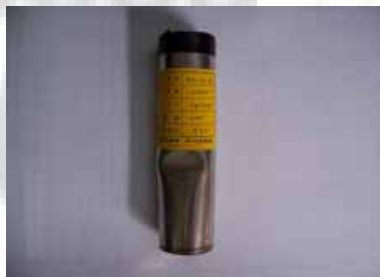
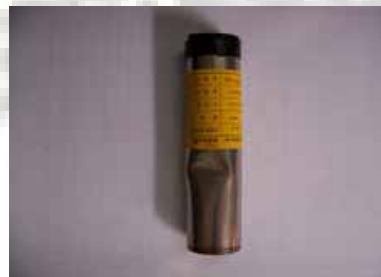
Photographs of specimen after test

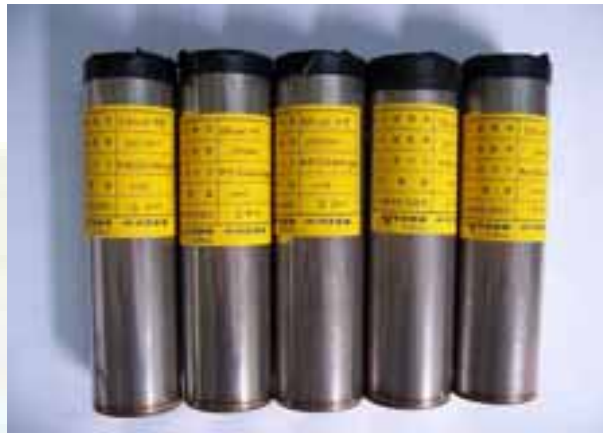
#26 ~ #30

Photographs of specimen before test

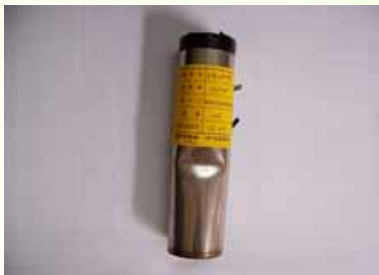
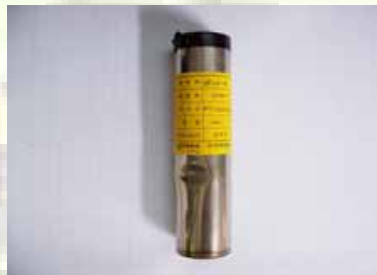
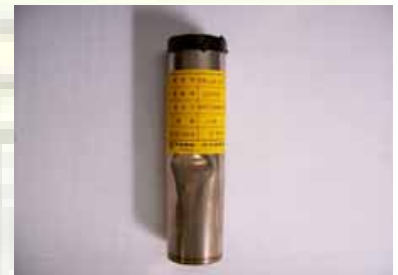
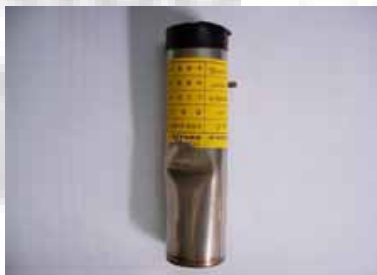
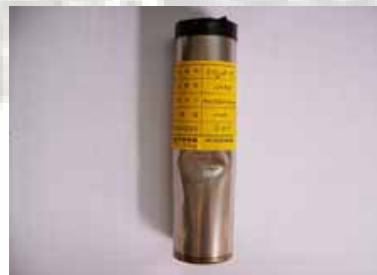
Photographs of specimen after test

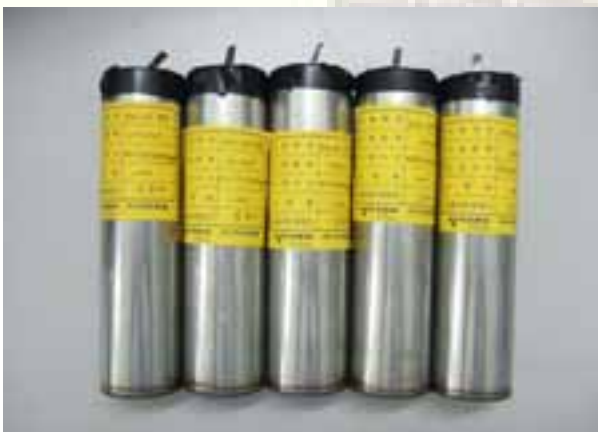
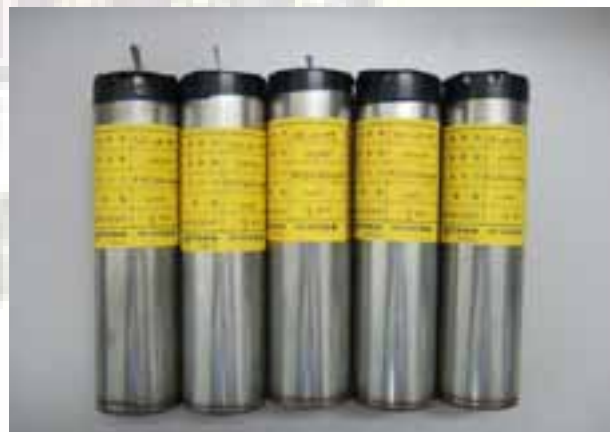
Photographs of specimen after test

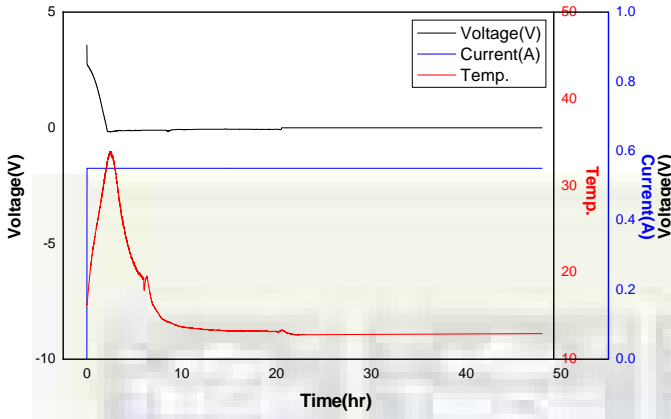
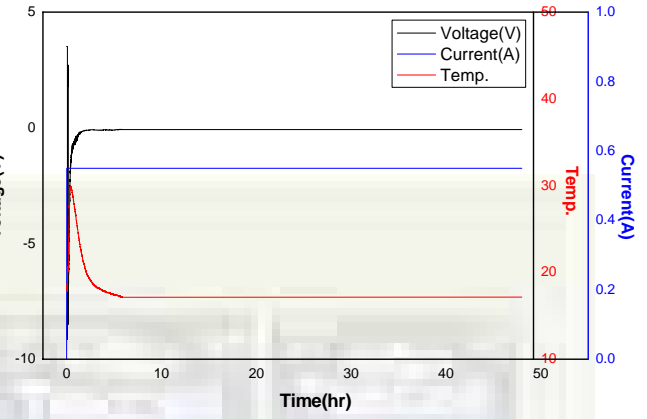
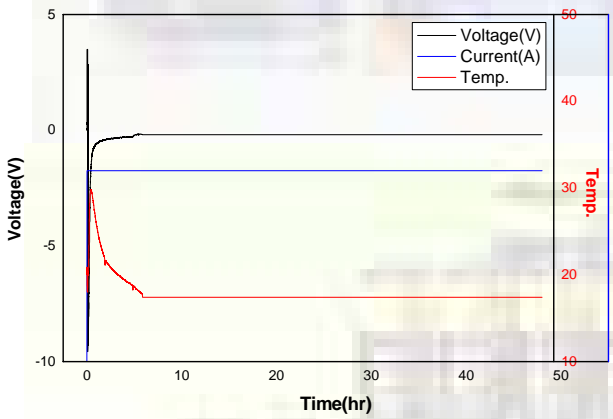
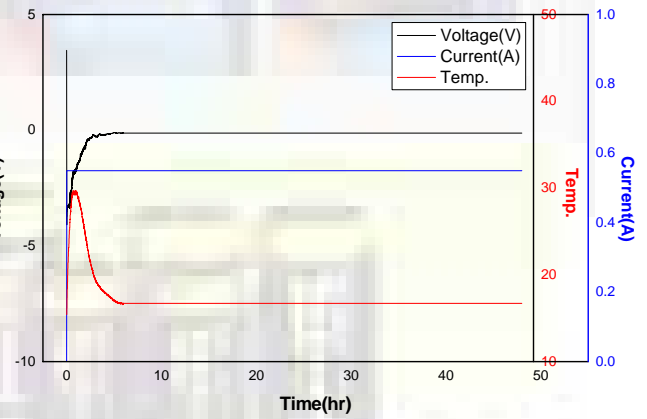
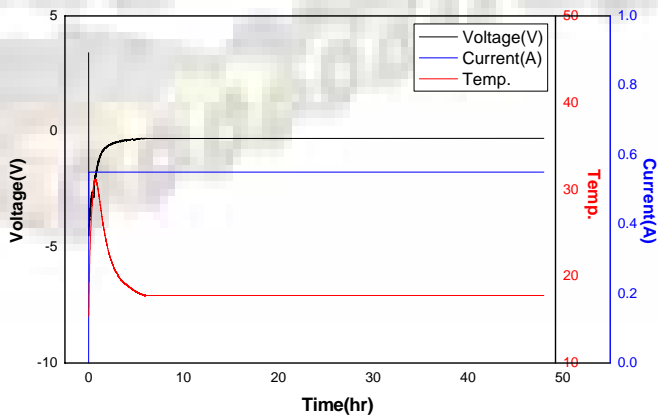
Discharge graph – Voltage and Current profile during Forced Discharge test(#31~#35)

[Discharge condition : 550mA/6hr]

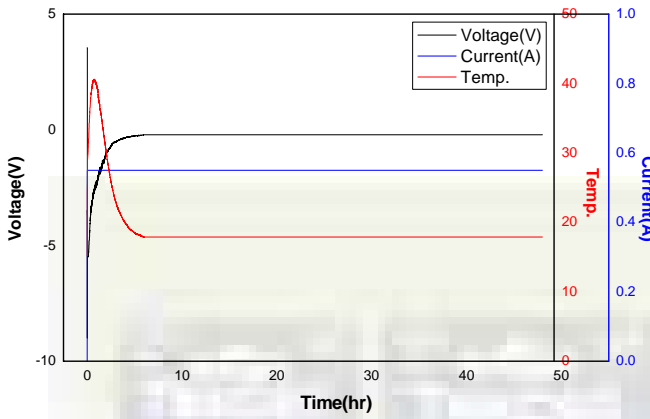
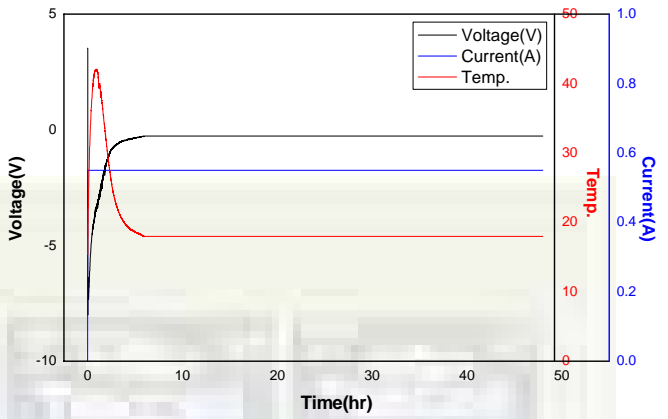
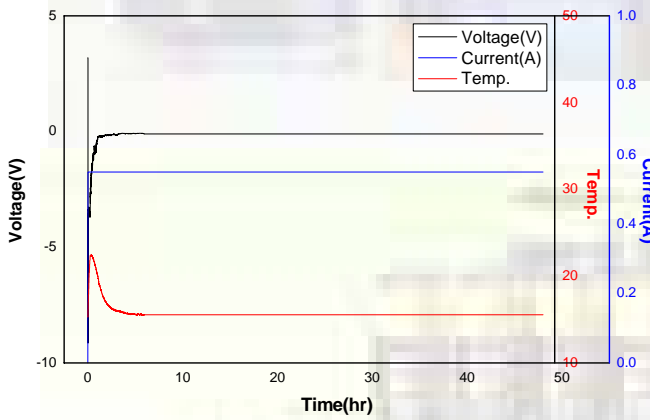
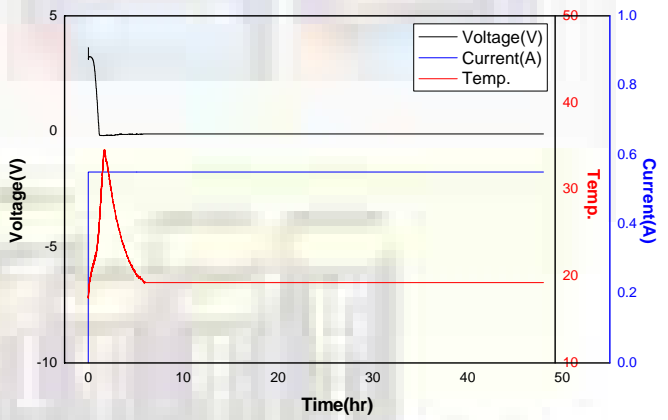
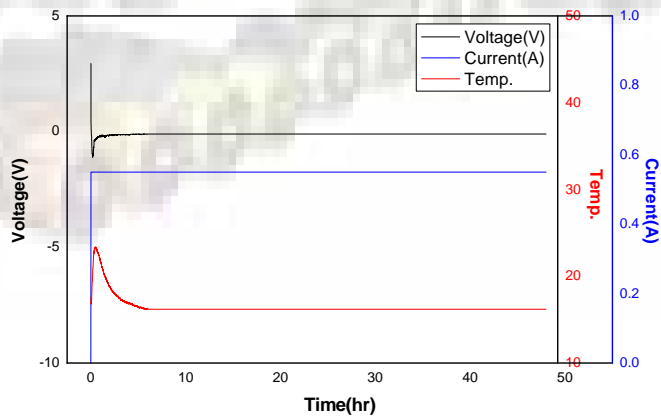
Discharge graph – Voltage and Current profile during Forced Discharge test(#36~#40)

[Discharge condition : 550mA/6hr]
